# **Learning from Accidents**

**Trevor  
Kletz**

Third edition

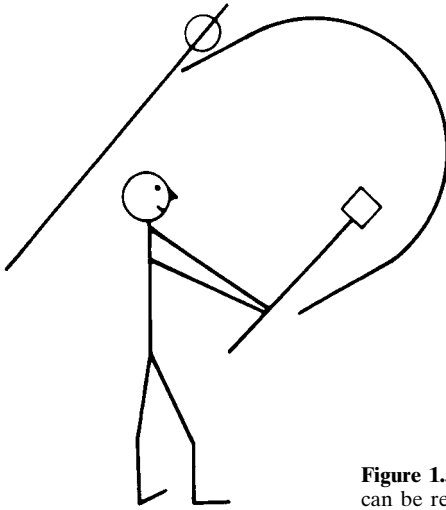
**Figure 1.5** The vessel is rotated so that the contents can be removed

It was then found that the welds between the lid and its hinges had cracked. It was a fatigue failure, caused by the strains set up by repeated opening and closing of the lid. There was nothing wrong with the original design but the lid had been modified about ten years before the incident occurred and, in addition, some repairs carried out a few years before had not been to a high enough standard.

Detailed recommendations were made for the repair of the lid. Though necessary they do not go far enough. If we look at the inner layers of the onion, four more recommendations are seen to be necessary (Figure 1.7):

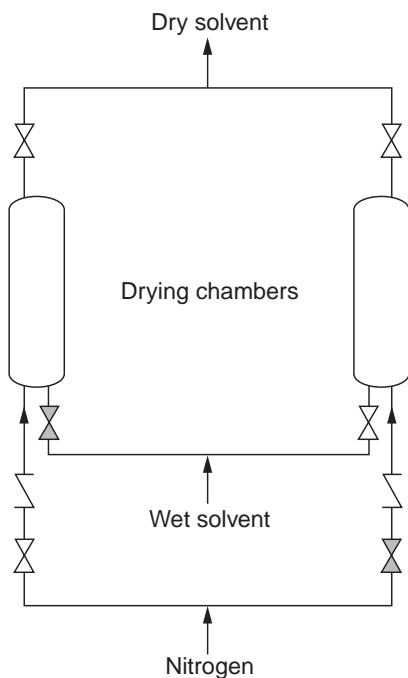
**Figure 2.1** Drying unit in which the accident occurred. (Regeneration lines not shown)

There was no leak from the drying unit or the main plant at the time and there was no flammable vapour present in the atmosphere. The fuel did not leak into the metal cabinet from outside, the route which had been foreseen and against which precautions had been taken, but entered with the nitrogen. The nitrogen supply was permanently connected to the driers by single isolation valves and non-return (check) valves as shown in Figure 2.1. The gauge pressure of the nitrogen was nominally 40 psi (almost 3 bar) but fell when the demand was high. The gauge pressure in the driers was about 30 psi (2 bar). Solvent therefore entered the nitrogen lines through

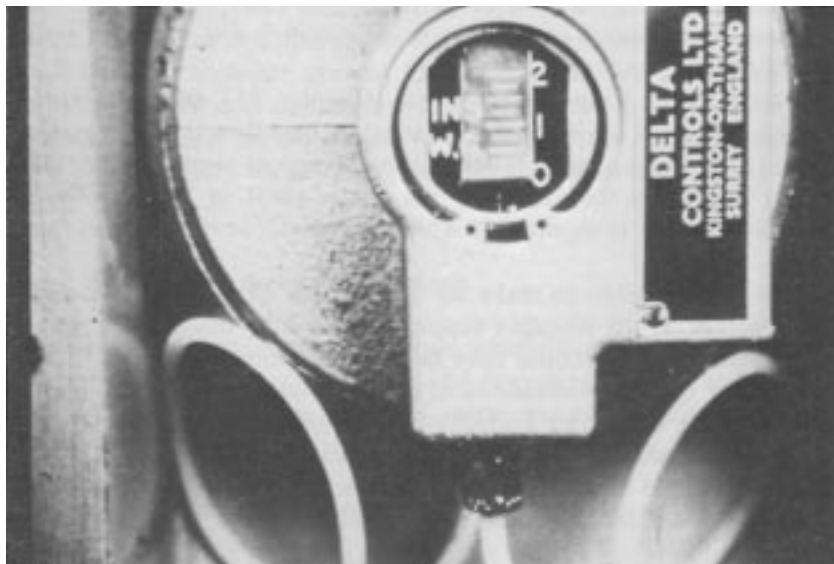
**Figure 2.4** Note that on the switch, as shown here with the cover removed, the set-point has been reduced enough to disarm the protective equipment

should have isolated the supply. The reason it did not do so is shown by Figure 2.4, a photograph of the pressure switch with the cover removed. It will be seen that the set-point has been reduced from 1/2 inch water gauge to zero. The switch cannot operate unless the pressure in the cabinet falls below zero, an impossible situation. The protective equipment had been effectively disarmed (that is, made inoperable).

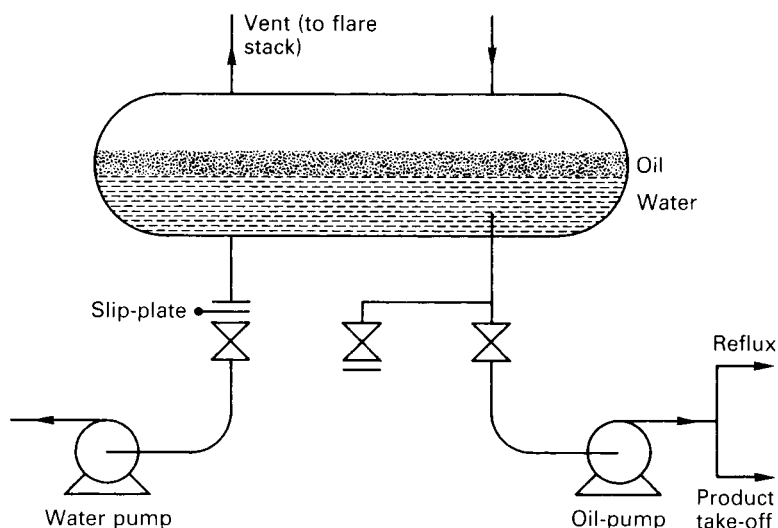
The foreman asked an operator to start up the water pump. He discovered that a slip-plate (spade) had been left in the suction line to the pump on the drum side of the isolation valve (Figure 3.1). All the branches on the drum had been slip-plated during the turnaround to isolate the drum for entry. The other slip-plates had been removed but this one had been overlooked by the fitter who removed them and this was not noticed by the process foreman when he accepted back the permit-to-work.

**Figure 3.1** The reflux drum and connections, showing the position of the slip-plate

Removing the slip-plate was more hazardous than it seemed at first sight because the gauge pressure at the slip-plate, due to the head of liquid, was nearly 10 psi (0.7 bar) higher than the pressure in the reflux drum (a gauge pressure of about 15 psi or 1 bar). This was not realised at the time. It might have been realised if those present had given themselves time to talk over the proposed course of action.

A shutdown could have been avoided with less risk by freezing the water above the slip-plate with solid carbon dioxide (dry ice) or by injecting water into the reflux drum via the spare branch shown in Figure 3.1 so as to maintain the level. Another possible way of avoiding the shutdown would be to remove the pump, pass a drill through the valve and drill through the slip-plate. This method could, of course, only be used if the valve was a straight-through type.

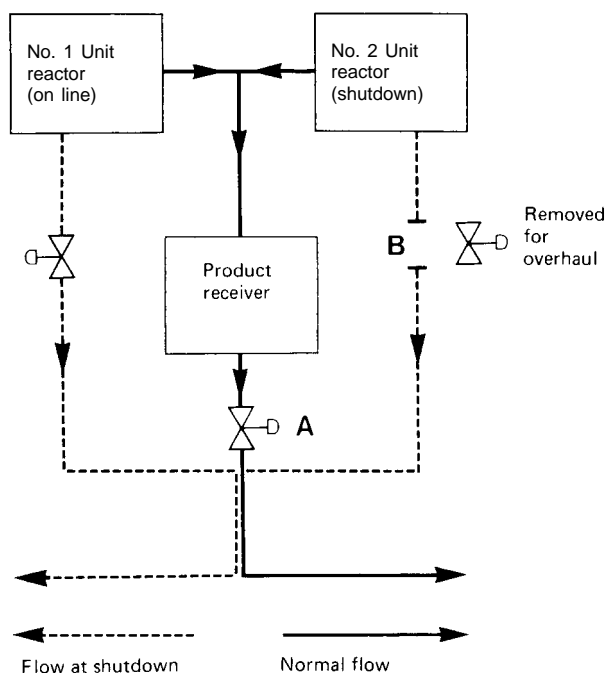
Valve B, in the by-pass line from the shutdown unit (No 2), had been removed for overhaul. A few hours later valve A was operated.

**Figure 5.1** Simplified flow diagram showing a combination of series and parallel equipment

Hot hydrocarbon (boiling point about 85°C, temperature about 150°C and gauge pressure about 7 bar [100 psi]) travelled in the wrong direction along No 2 unit by-pass line and came out of the open end. Someone sounded the evacuation alarm and the eighty maintenance workers who were on the plant at the time, working on No 2 unit, started to leave. Unfortunately, for some of them the direct route to the main gate and assembly point lay close to the leak. As they were passing it, ninety seconds after the leak started, the hydrocarbon ignited. However, most of the maintenance workers escaped without injury.

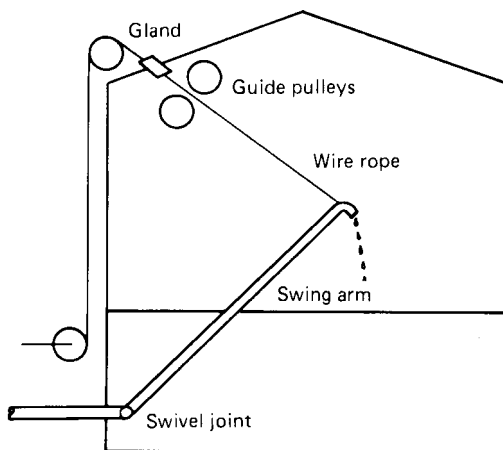
**Figure 6.2** The tank was being splash-filled through a swing arm which was stuck in the raised position. (Drawing not to scale)

suction (Figure 6.2). As a result the composition of the vapour space reflected the composition of the incoming, splashing liquid rather than the composition of the bulk of the liquid in the tank and the vapour composition changed as soon as the composition of the incoming liquid changed. This probably explains why the explosion occurred soon after the upset on the distillation column.

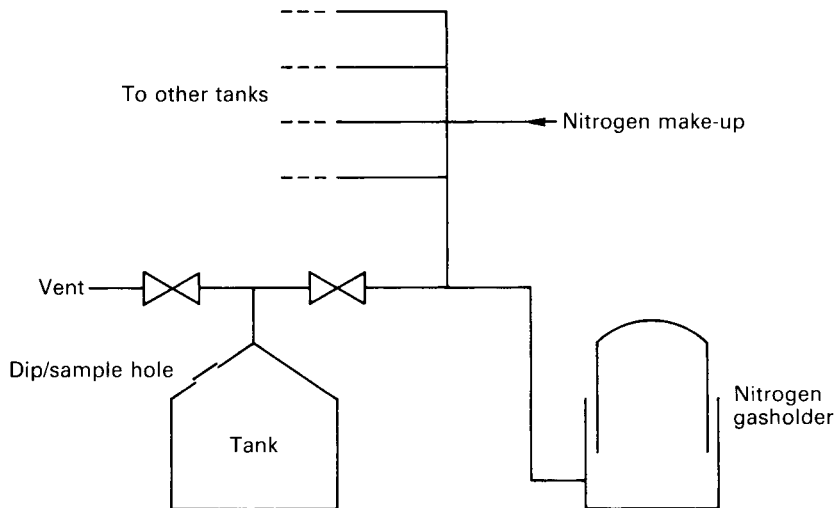
**Figure 6.3** The tank was connected to the nitrogen gasholder but could be isolated and vented while it was dipped

and to do this they had to be disconnected from the gasholder and vented to atmosphere for a short time, otherwise nitrogen would be wasted and would also be discharged from the dip hole close to the dipper (Figure 6.3).

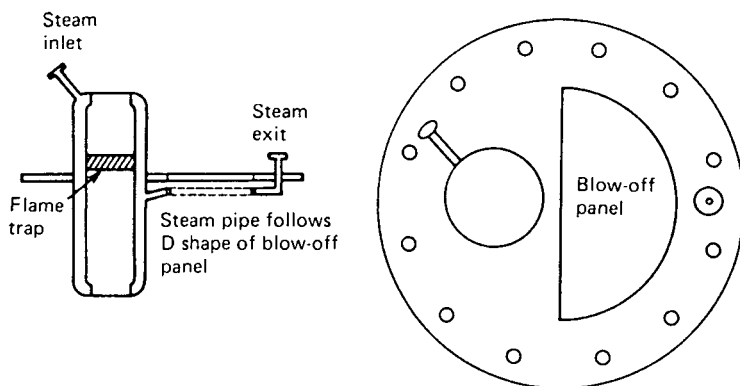
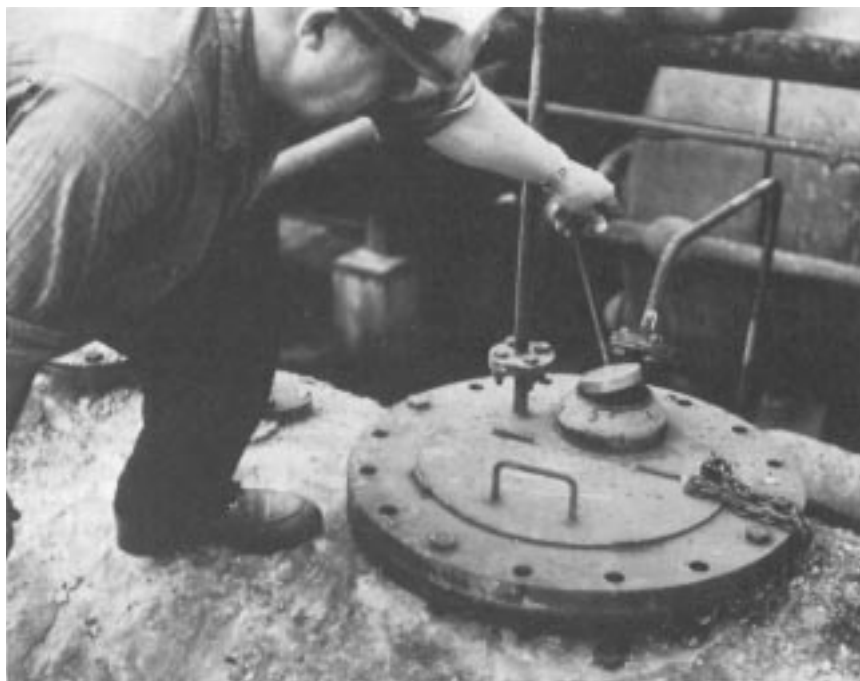
Figures 7.2 and 7.3 illustrate the flame trap assembly that was fitted to 200 tanks, in place of the manhole cover, after the accident<sup>10</sup>. The device consisted of a short length of steam-jacketed pipe into which a crimped ribbon flame arrester was fitted. A long handle on the flame arrester enabled it to be removed, without the use of tools, and held up to the light for inspection. The inspector could also look through the vent hole into the tank to see that there was no obstruction. Adequate access was, of course, provided. Should the flame trap have choked, or been unable to pass the required quantity of gas, a loose D-shaped lid lifted and relieved the pressure. A chain prevented the lid going into orbit. Steam tracing prevented the lid from being stuck in position by adhering solid.

The steam jacket extended at least 3 inches (75 mm) into the tank to prevent a bridge of solid forming across the bottom. The flame arrester was about 9 inches (225 mm) from the bottom of the vent and about 3–4 inches (75–100 mm) from the top.

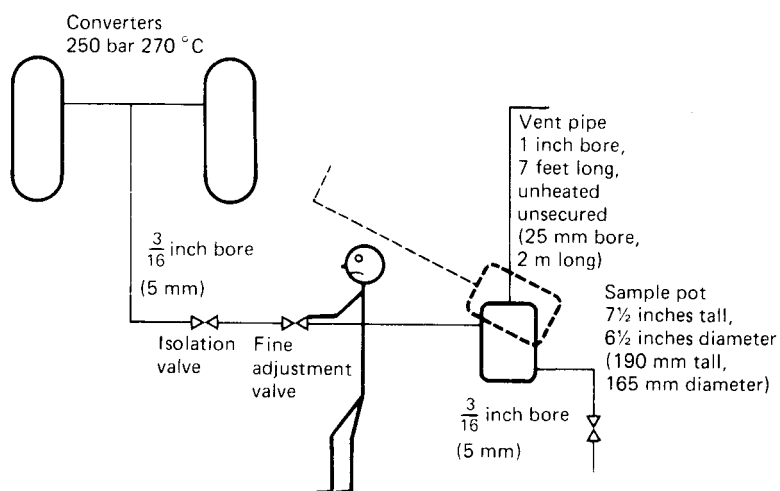
**Figure 7.4** An attempt to clear a choke and obtain a sample from the line joining two reactors

A vegetable oil was being hydrogenated on a pilot plant and samples had to be taken from the line joining two reactors (Figure 7.4). The sample pot was filled by opening the isolation valve and cracking open the fine adjustment valve. Both valves were then closed and the sample drained into a sample can. As the oil and product had a melting point of 20°C, all lines were steam traced, except for the vent line.

The sample pot and vent line had not been clamped and were free to rotate by partially unscrewing the flange on the inlet pipe. It had been intended to clamp them but this had been overlooked. It is believed that there was a choke somewhere in the system, probably in the vent pipe which was not heated, and that when it cleared the back pressure from the sudden rush of gas caused the vent pipe to move backwards.

The main recommendation of the report was that plants handling materials which are solid at atmospheric temperature should be adequately heated. This applied particularly to the vent pipe.

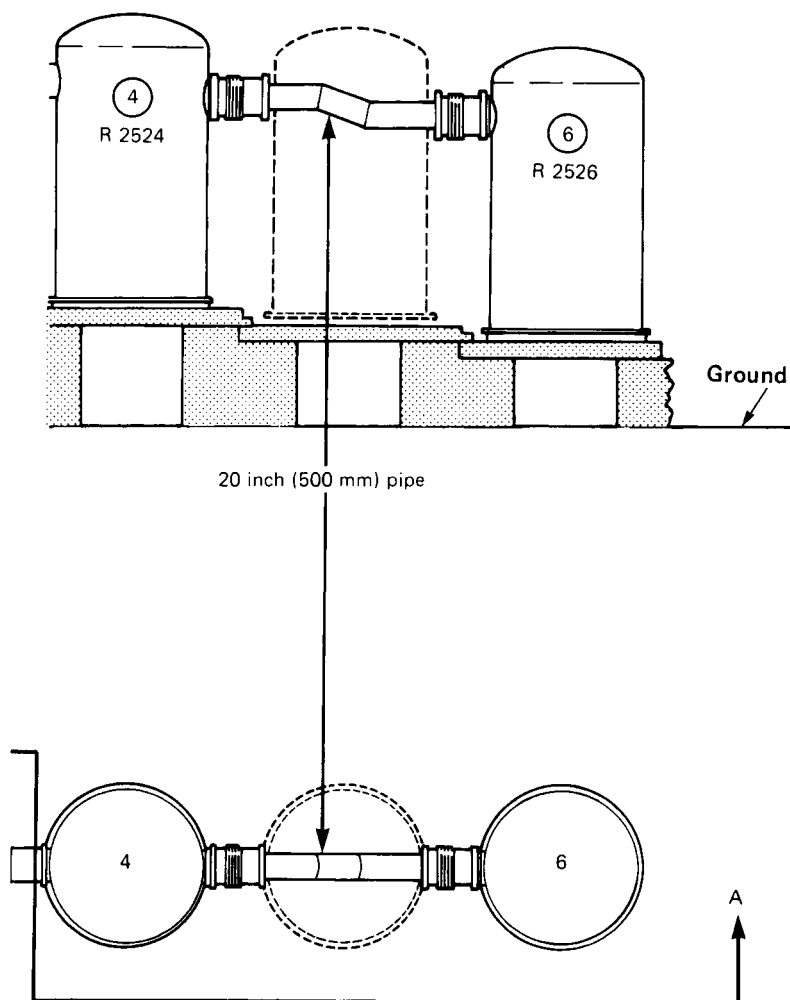
**Figure 8.1** Arrangement of reactors and temporary pipe at Flixborough. (Reproduced by permission of the Controller of Her Majesty's Stationery Office)

One of the reactors developed a crack and was removed for repair. In order to maintain production a temporary pipe was installed in its place. Because the reactors were mounted on a sort of staircase, so that liquid would overflow from one to another, this temporary pipe was not straight but contained two bends (Figure 8.1). It was 20 inches diameter although the short pipes which normally joined the reactors together were 28 inches diameter. Calculation showed that 20 inches would be adequate for the flow rates required. Bellows, also 28 inches diameter, were installed between each reactor and these were left at each end of the temporary pipe.

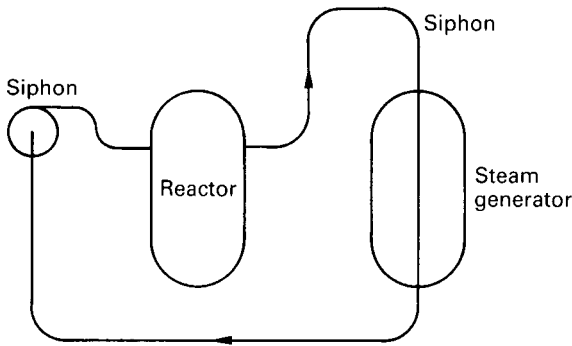
**Figure 11.2(a)** In the Three Mile Island design small differences in height and siphons prevent convective circulation

A halfway-house to inherently safer designs are those containing passive safety features. For example, in Three Mile Island and other early PWR designs the heat source, the core, is only a little below the heat sink, the steam generator, and so there is little or no convection cooling if the circulation pumps stop (Figure 11.2a). In addition, at Three Mile Island, siphon loops (high points in the piping) filled with steam and prevented flow and other obstructions increased the pressure drop. These problems are overcome in the modern design shown in Figure 11.2b. The steam generator is well above the core and there are no siphon loops. Convection cooling can supply 25% of the full cooling load<sup>21</sup>.

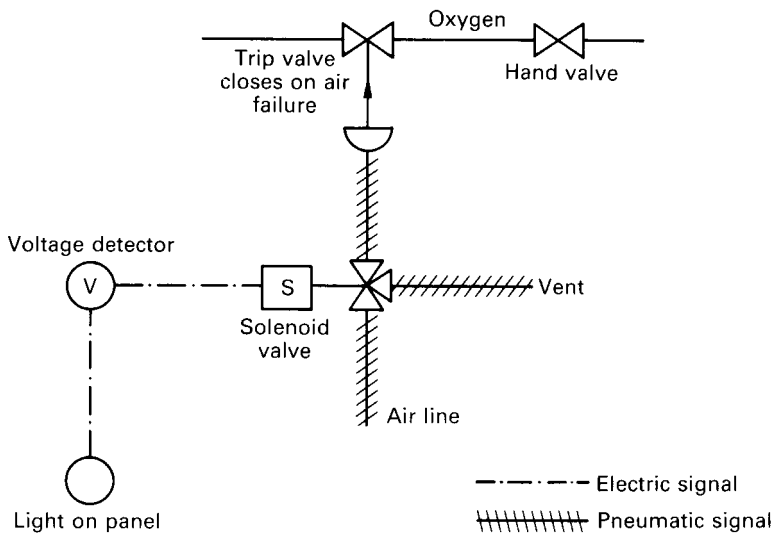
The valve was a pneumatic one and was closed by venting the air supply to the valve diaphragm, via a solenoid valve (Figure 11.3). The light on

**Figure 11.3** The light shows that the solenoid is de-energised, not that the oxygen flow has stopped

the panel merely said that the solenoid valve had been de-energised. Even though this occurs the solenoid valve may not move, the air may not be vented or the trip valve may not move. With some designs of valve the spindle can move without the valve closing. Actually, the air was not vented as the 1 inch vent line was plugged by a wasp's nest. The incident occurred in Texas where the wasps are probably bigger than anywhere else.

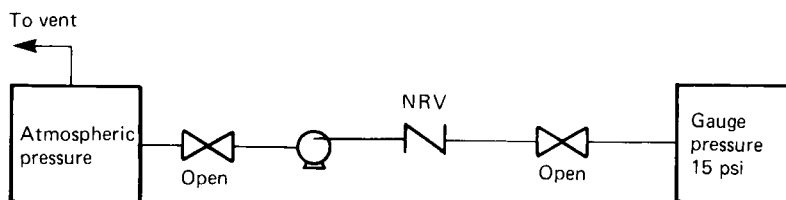
The first dangerous occurrence: liquid was pumped intermittently from an atmospheric pressure storage tank to one which was kept at a gauge pressure of 1 bar. The pump suction and delivery valves were kept open and a non-return valve was relied on to prevent backflow (Figure 15.1).

**Figure 15.1** When the NRV failed, a leak was inevitable (see item 4)

A piece of wire, about 3 inches long, became stuck in the non-return valve and the atmospheric pressure storage tank overflowed. Two tonnes of liquid were spilt.

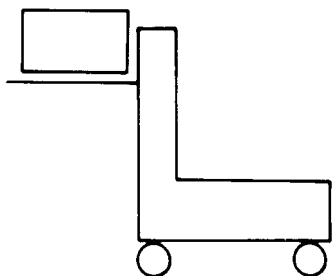
Full 40-gallon drums were being loaded onto a flat wagon with a fork lift truck. The drums were stored on their sides in tiers, as in Figure 15.3. Two drums were lifted onto the wagon at a time (Figure 15.4) and then tipped into a vertical position with the ends of the forks (Figure 15.5). One tipped too far and fell onto the foot of the driver who was standing on the wagon to adjust the position of the drums.

**Figure 15.4** Drums are lifted two at a time like this onto a flat wagon

One possible solution would have been to store the drums on their ends and lift them onto the wagons with a suitable attachment fitted to the fork lift truck. However, this would need extra storage space and would not be the complete answer as a layer of horizontal drums was put on top of the vertical layer (Figure 15.6).

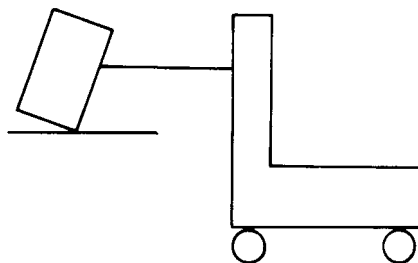
**Figure 15.5** ...and then tipped up like this (see Accident 29)

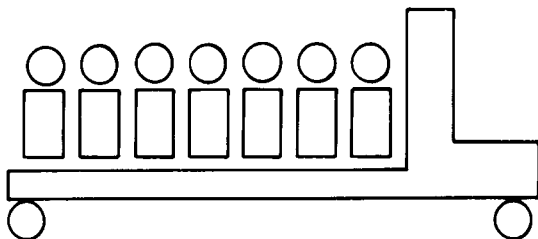
One customer would not accept wagons with the upper horizontal layer of drums as a man had been killed when one of these drums fell off. This illustrates one of the problems of industrial safety. There may be a case for forbidding the top layer of drums at all times; there may be a case for allowing it to continue. There is no logic in stopping it at the site where the accident occurred but allowing it to continue elsewhere.

**Figure 15.6** Method of carrying drums on a flat wagon (see Accident 29)

We felt that this problem called for more expertise than we, or any of the local management, possessed and we recommended that it was referred to consultants.

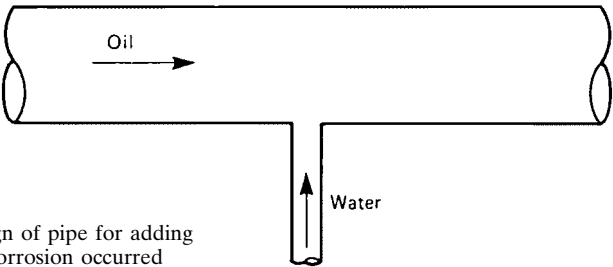
(A1) Water was added to an oil stream using a simple T-junction (Figure 16.1). The water did not mix with the oil and extensive corrosion occurred downstream of the junction. There was a major fire.

**Figure 16.1** Original design of pipe for adding water to an oil stream. Corrosion occurred

The corrosion would not have occurred if the water pressure had been higher, so that the water hit the opposite wall of the pipe, or if the water had been added to the centre of the oil line as shown in Figure 16.2.

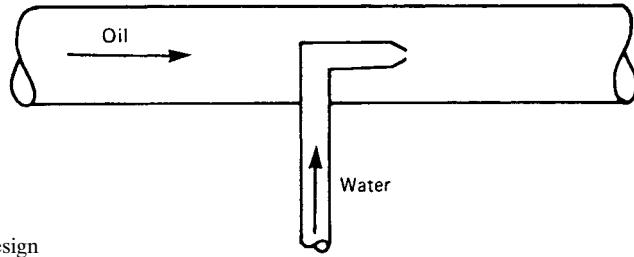
**Figure 16.2** A better design

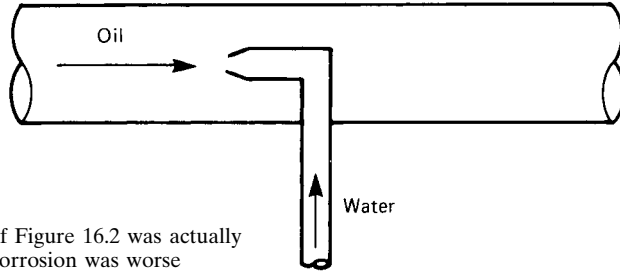
**Figure 16.3** The design of Figure 16.2 was actually assembled in this way. Corrosion was worse

(A2) A device to achieve this was designed for another plant. It was assembled as shown in Figure 16.3. Corrosion was worse! Once the device was assembled it was impossible to tell if it had been assembled correctly. It should have been designed so that there was a tell-tale sign on it or, better still, so that it could not be assembled incorrectly.

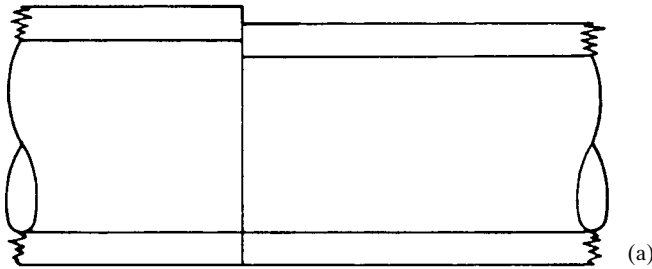
**Figure 16.5** (a) and (b) Two pipes of slightly different diameter were welded together

(B7) Two lengths of 8-inch (200 mm) pipe which had to be welded together were not exactly the same diameter so the welder joined them with a step between them over part of the circumference (Figure 16.5(a) and (b)). The pipe was then insulated. The botched job was not discovered until ten years later when the insulation was removed for inspection of the welds.

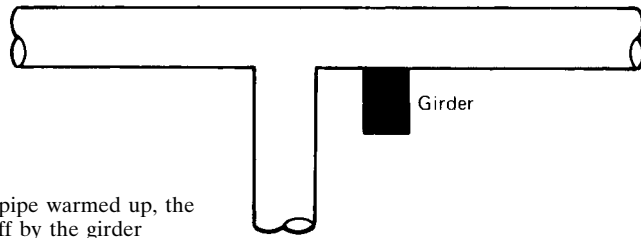
(B10) A 10-inch (250 mm) pipe was fitted with a  $\frac{3}{4}$  inch (20 mm) branch. The main pipe rested on a girder and there was a gap of 5 inches (125 mm) between the branch and the girder (Figure 16.7). When the pipe was brought into use its temperature rose to 300°C. The branch came into contact with the girder and was knocked off. Calculation showed that the pipe, which was 120 feet (36 m) long, had moved 6 inches (150 mm).

Again, it is unlikely that the designer specified precisely how the branch was to be positioned in relation to the girder and that he left this detail to be decided on site. The construction workers would not have known the operating temperature of the pipe or how much it would expand.

**Figure 16.7** When the pipe warmed up, the branch was knocked off by the girder

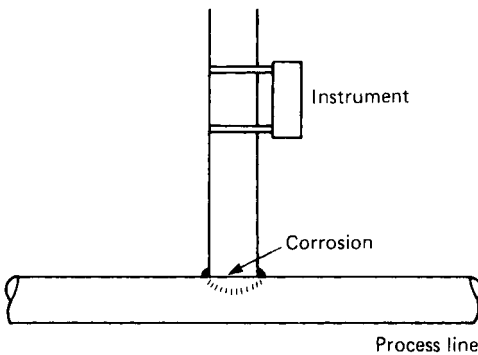
**Figure 16.12** Water collected in a piece of pipe, used as an instrument support, and corrosion occurred

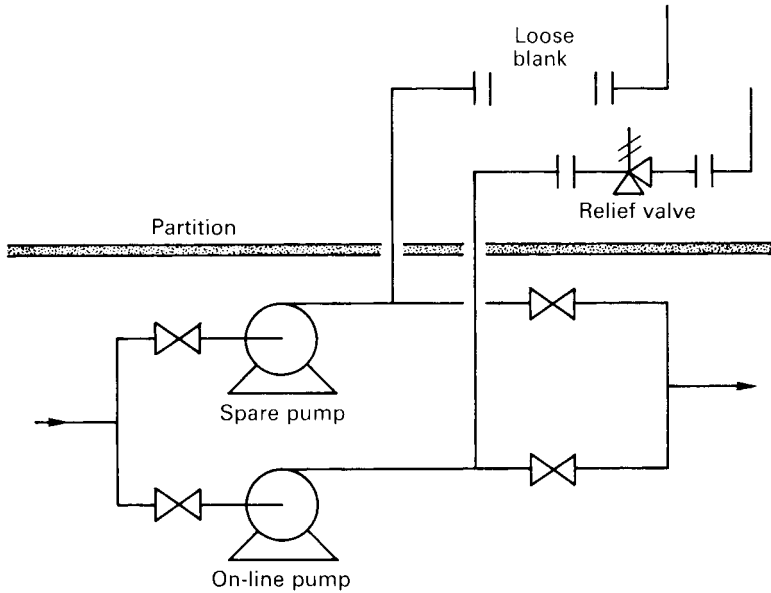
However, they were not aware, but should have been, that a second maintenance job had been started on that spare pump during the day. A relief valve on its delivery pipe had been taken off in order to check its set pressure. The work had not been completed by 18.00 hours, the end of the day shift, and refitting the relief valve had been left over for the following day. When the night shift opened up the pump's suction valve in preparation for starting-up, condensate leaked from the site of the removed relief valve. A blank flange assembly at the site of the relief valve was not leak tight. It was that leak which ignited and exploded (Figure 17.2).

**Figure 17.2** Piper Alpha: the on-line pump broke down so the other pump, which was shut down for overhaul and for testing of the relief valve, was brought on line. The operators did not know that the relief valve had already been removed and the open end loosely blanked

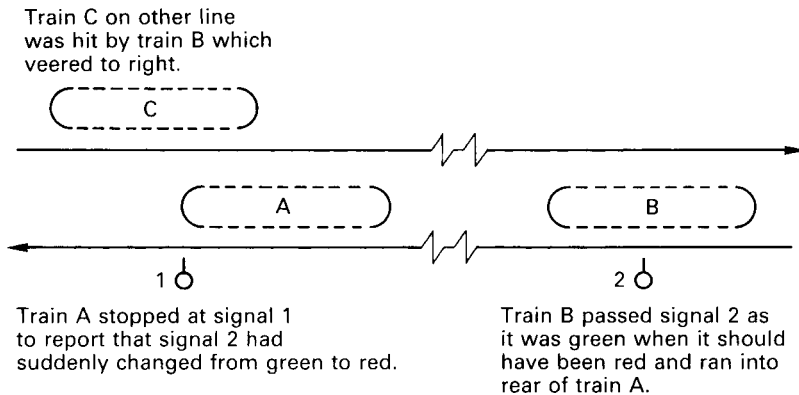
The stationary train (A) had stopped because a signal suddenly changed from green to red when the train was almost on top of it. In accordance with instructions the driver stopped at the next signal to report the fault by telephone to the signalman. He assumed, as he had every right to do, that the track-circuiting would detect the presence of his train on the tracks and would keep the previous signal at red. Unfortunately there was a fault in this signal, a wrong side failure; it was green when it should have been red; it was inviting the next train (B) to pass it and enter the section already occupied by the stationary train (A) (Figure 19.2).

**Figure 19.2** The Clapham Junction railway accident

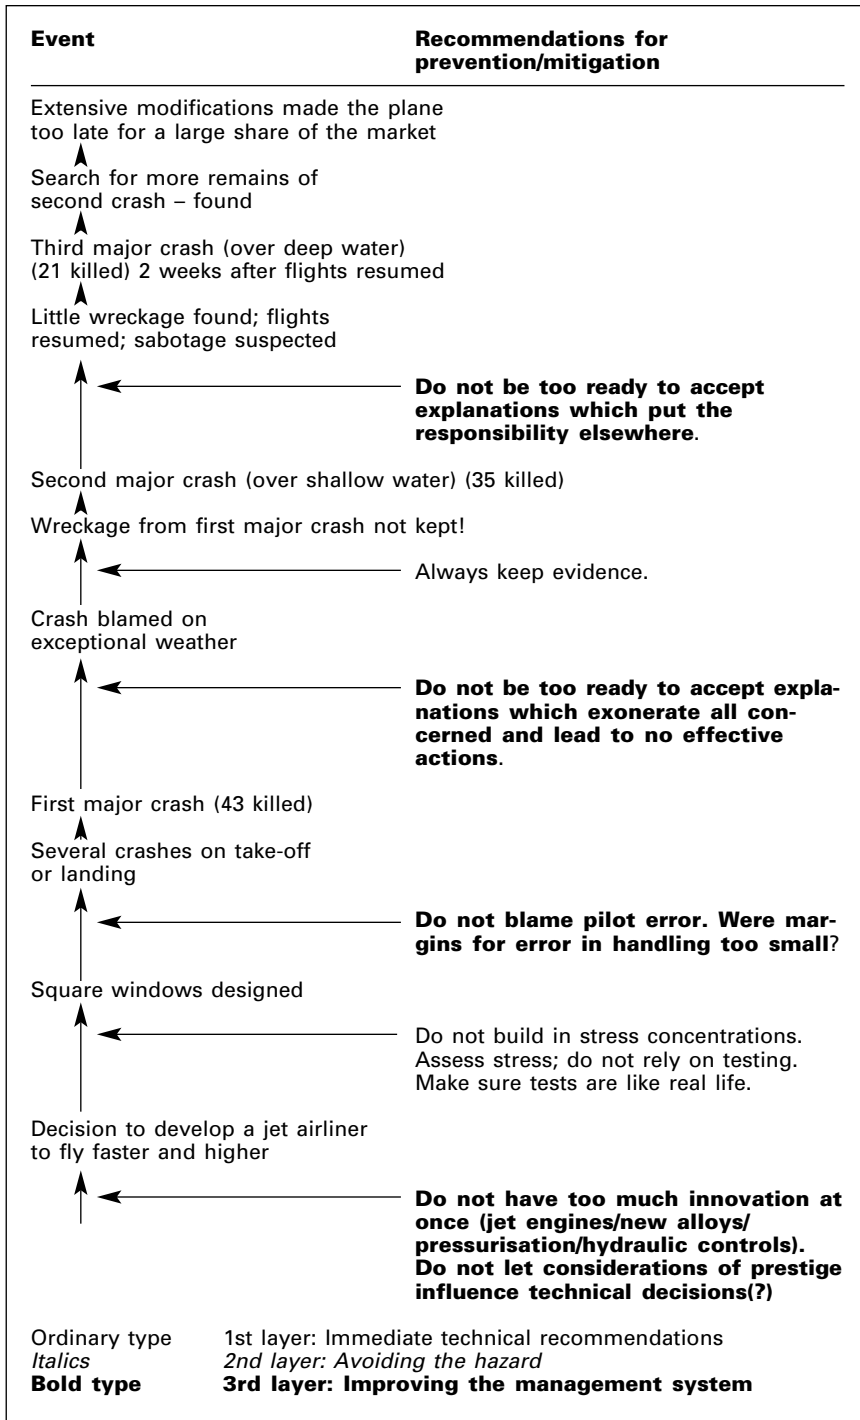
Figure 21.2 The Comet crashes 1953/4

The story of the major crashes illustrates our reluctance to accept that anything is fundamentally wrong until the evidence becomes overwhelming. The first crash, in October 1952, in which no one was killed, and the second, in March 1953, a delivery flight, in which eleven people were killed, were blamed on pilot error. The first major crash, in India in May 1953, which killed forty-three people, was blamed on an exceptional gust of wind, so high that it would have endangered any aircraft. The wreckage was scattered over 2 square km. Pressure tests on a fuselage showed that stress concentrations at the corners of the square windows could cause fatigue failures but the test conditions were so extreme that they could not occur in flight.

The second major failure, in which thirty-five people were killed occurred over the sea near the Italian coast in January 1954. Again, many pieces of wreckage were spread over a wide area. Some of the wreckage was recovered but despite intensive investigations no cause could be found. Sabotage was suspected. Some minor changes were made, including fitting armour plating round the engines so that engine failure could be contained, and flights were resumed.

Two weeks later, in April 1954, a third Comet, with twenty-one people on board, disappeared over the Mediterranean. The water was too deep for recovery of the wreckage but more wreckage from the second major crash was recovered. This showed that fatigue cracks near the window corners had led to failure of the fuselage.

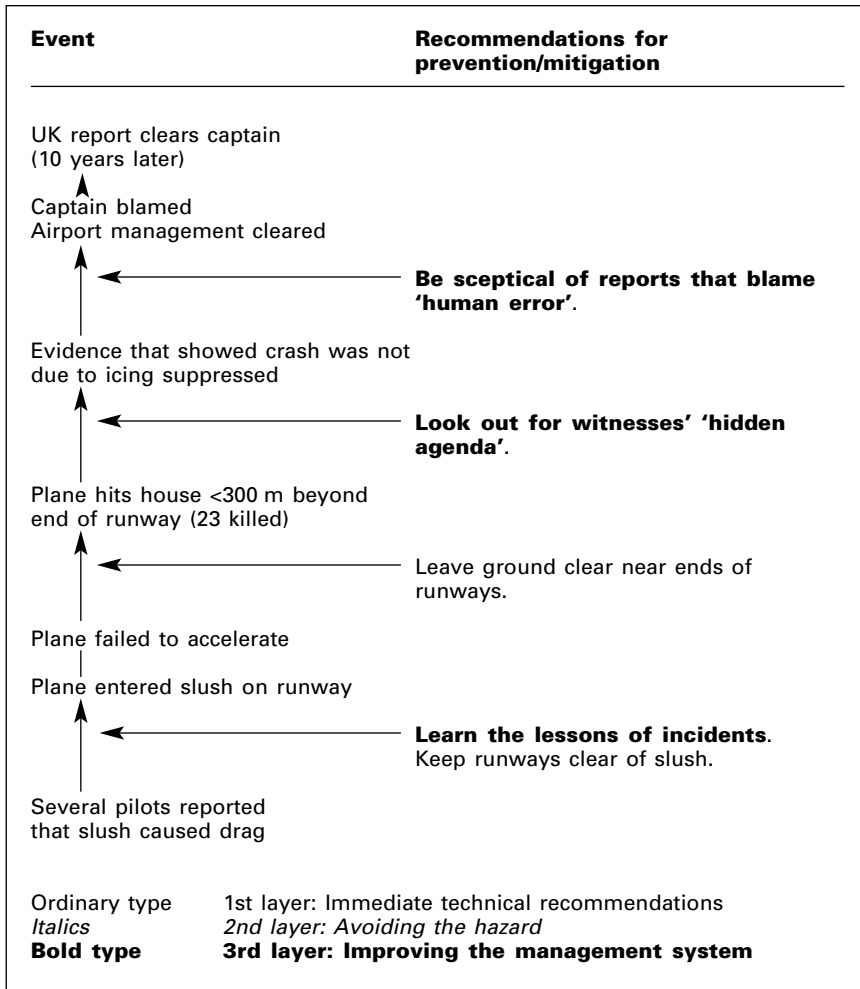
**Figure 21.3** The Munich crash 1958

In 1958 a British European Airways Ambassador aircraft, taking off from Munich airport, failed to clear the end of the runway and crashed into a house less than 30 m beyond the end. Of the forty-four people on board, twenty-three were killed, including eight players and four other employees of Manchester United football team.

The weather was bad. There were several centimetres of slush on the runway and some of the other planes taking off at about the same time had been de-iced. The captain of the British plane decided that this was not necessary and the German inquiry blamed the accident on his error of judgement.

At the time the effect of slush on acceleration was not fully understood or the runway might have been cleared. As evidence accumulated, from experiments and from reports by other pilots, that slush might have been responsible, there were calls for the inquiry to be re-opened but the German authorities refused. Finally, ten years after the accident a British Commission cleared the captain, who had survived. One of their witnesses was the first man on the scene after the crash; he had examined

the wings and found no ice on them. He had not been called to the German inquiry, only someone who detected a patch of ice six hours later.

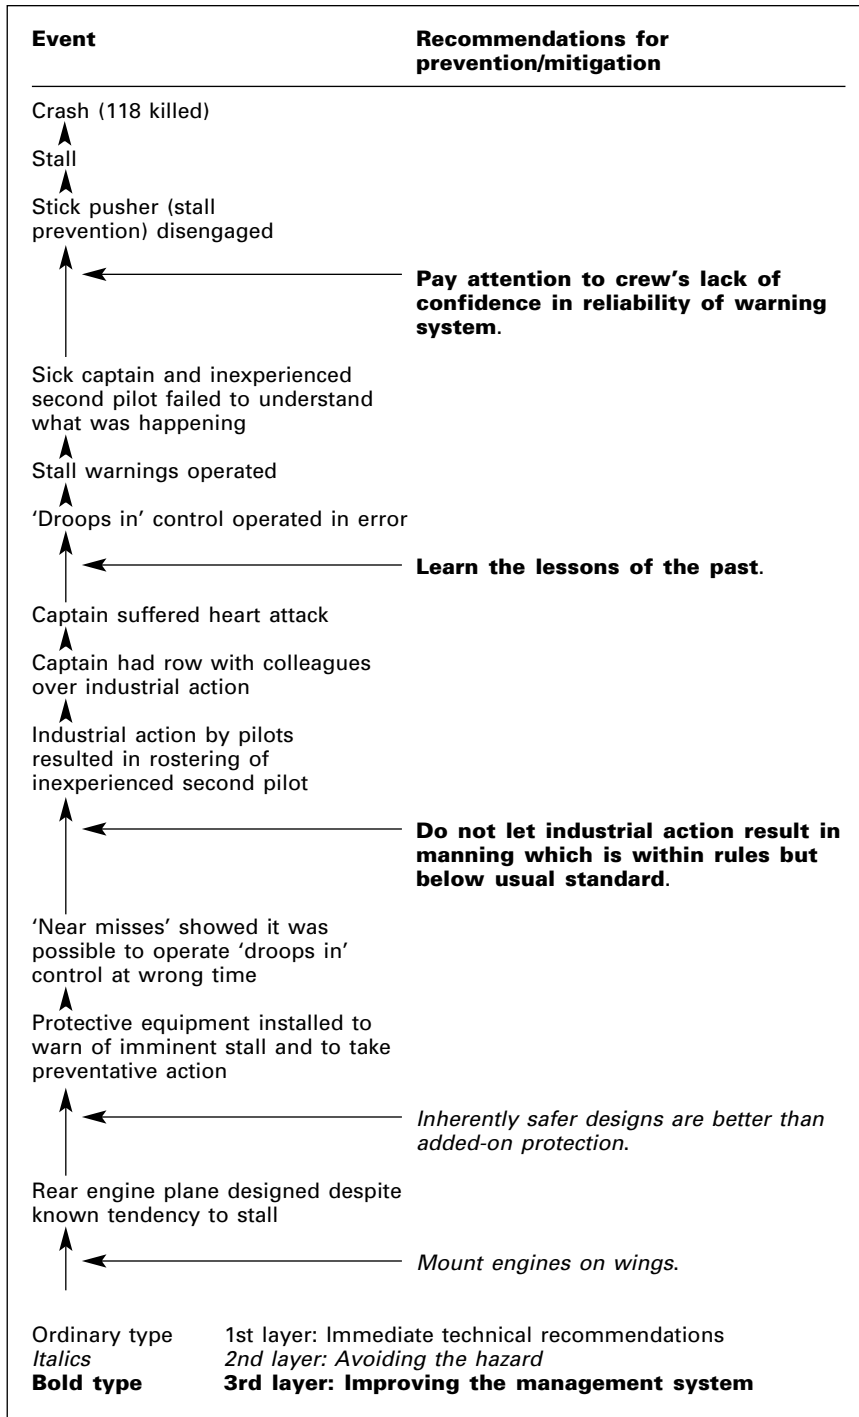
Figure 21.4 The Trident crash at Heathrow 1972

In 1972 a British European Airways Trident crashed soon after leaving London's Heathrow Airport. All the 118 people on board were killed. The triggering event was the sort of human error that is sooner or later inevitable. The underlying cause was a weakness in design.

At the time many pilots were on strike and an inexperienced pilot was rostered as second officer. The captain had had a row with his colleagues before joining the plane and suffered a heart attack during take-off. With a combination of illness and inexperience the crew were unable to prevent the stall.

It is not helpful to say that the accident was due to human error, made worse by illness and inexperience. The error was a result of poor design. Designers should realise that operators cannot always perform perfectly and design accordingly. We all have days when, for one reason or another, we do not perform as well as we normally do.

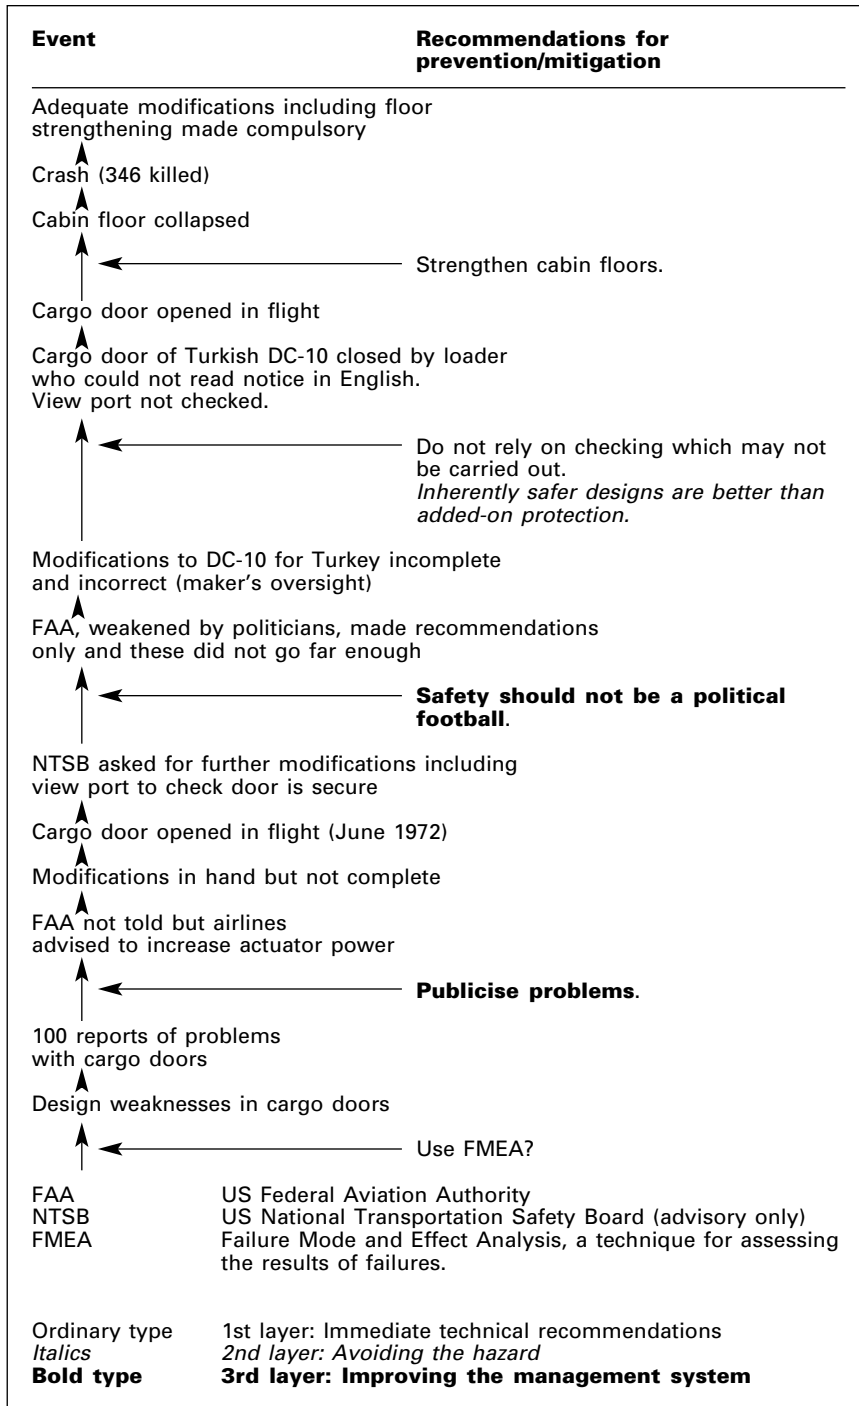
Figure 21.5 The Paris DC-10 crash 1974

The National Transportation Safety Board (NTSB), an advisory body, asked for further modifications, including a more foolproof design of closing mechanism. The FAA, weakened by politicians, made recommendations only and they did not go as far as the NTSB wanted. They did, however, ask for a peephole or viewing port by the door so that the man closing it could see if the catch was home. A diagram by the door told him what to look for. As in the last incident, protective devices did not remove the hazard; they merely allowed someone to check that the door was secure.

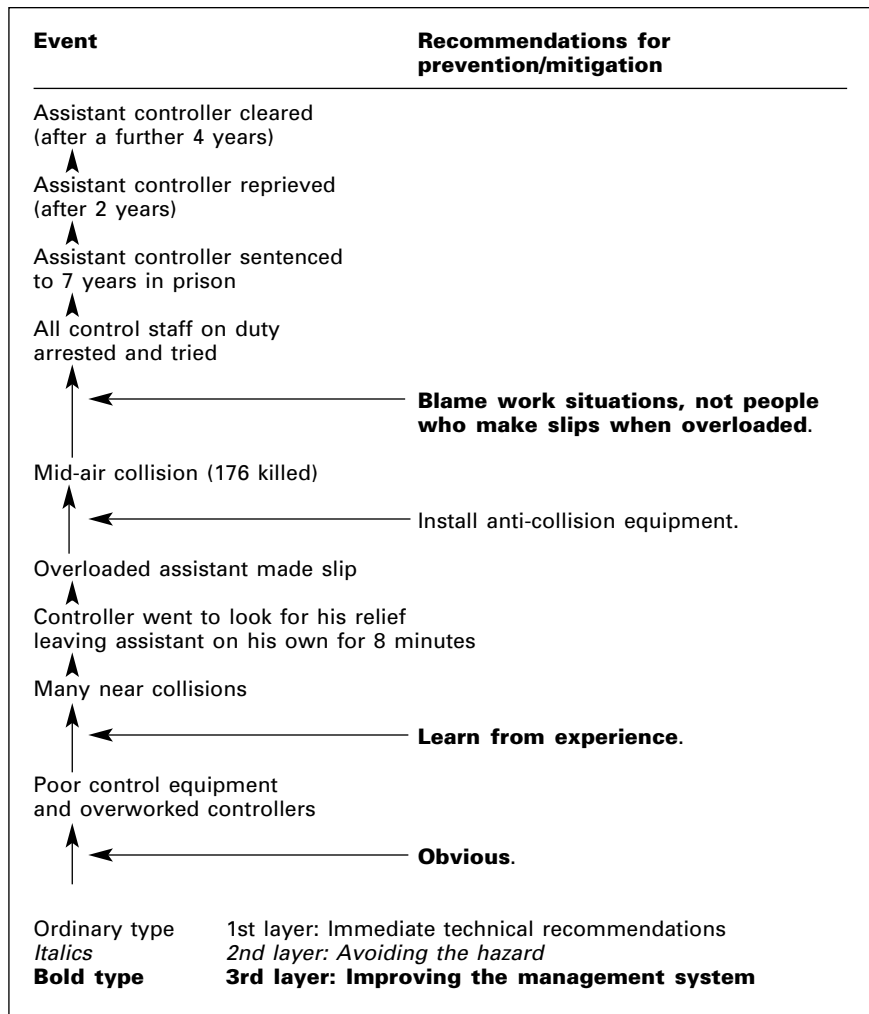
**Figure 21.6** The Zagreb mid-air collision 1976

In 1976 the control equipment at Zagreb airport was poor and the controllers were overworked. There had been thirty-two near-miss collisions in the previous five years. A relief controller was late arriving and the senior controller left his seat for eight minutes in order to look for him, leaving an assistant in charge of the section. As the result of a misunderstanding during the brief handover, compounded by a missing arrow on the screen which should have shown that an aircraft was climbing, two aircraft collided in mid-air with the loss of 176 lives.

All the controllers on duty were put on trial for criminal misconduct but all except the assistant were acquitted. He was sentenced to seven

years imprisonment, halved on appeal. He was released after two years and in 1982 a re-convened investigation agreed that the assistant had been overloaded.

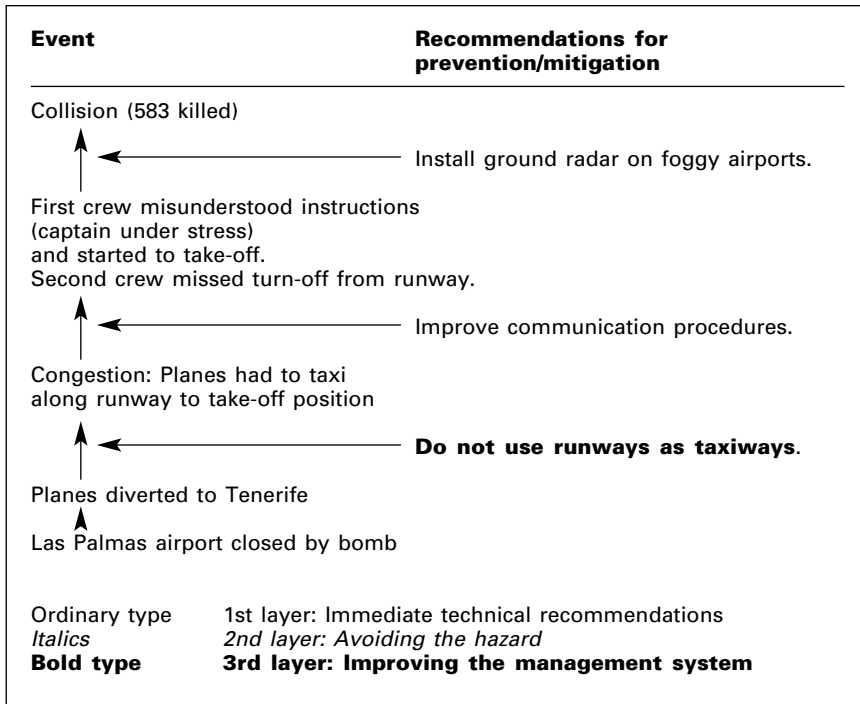
**Figure 21.7** The Tenerife ground collision 1977

In March 1977 two 747 Jumbo jets collided on the ground at Los Rodeos Airport, Tenerife in the Canary Islands. Of the passengers and crew on the two planes 583 were killed and only seventy survived.

The main airport in the Islands, Las Palmas, had been closed following a bomb explosion and planes were diverted to Los Rodeos. The airport was congested and planes had to taxi along the runway to reach their parking or take-off positions instead of using the normal taxiway parallel to the runway. Fog made visibility poor.

Using the runway as a taxiway is obviously bad practice, particularly when crews cannot see whether or not it is clear, and was used only because the airport was overcrowded. Once again we see people trying to control a hazard by procedures which are subject to occasional but inevitable misunderstandings and mishearings, rather than avoiding the hazard (by sticking to separate runways and taxiways) or installing better control equipment (ground radar).

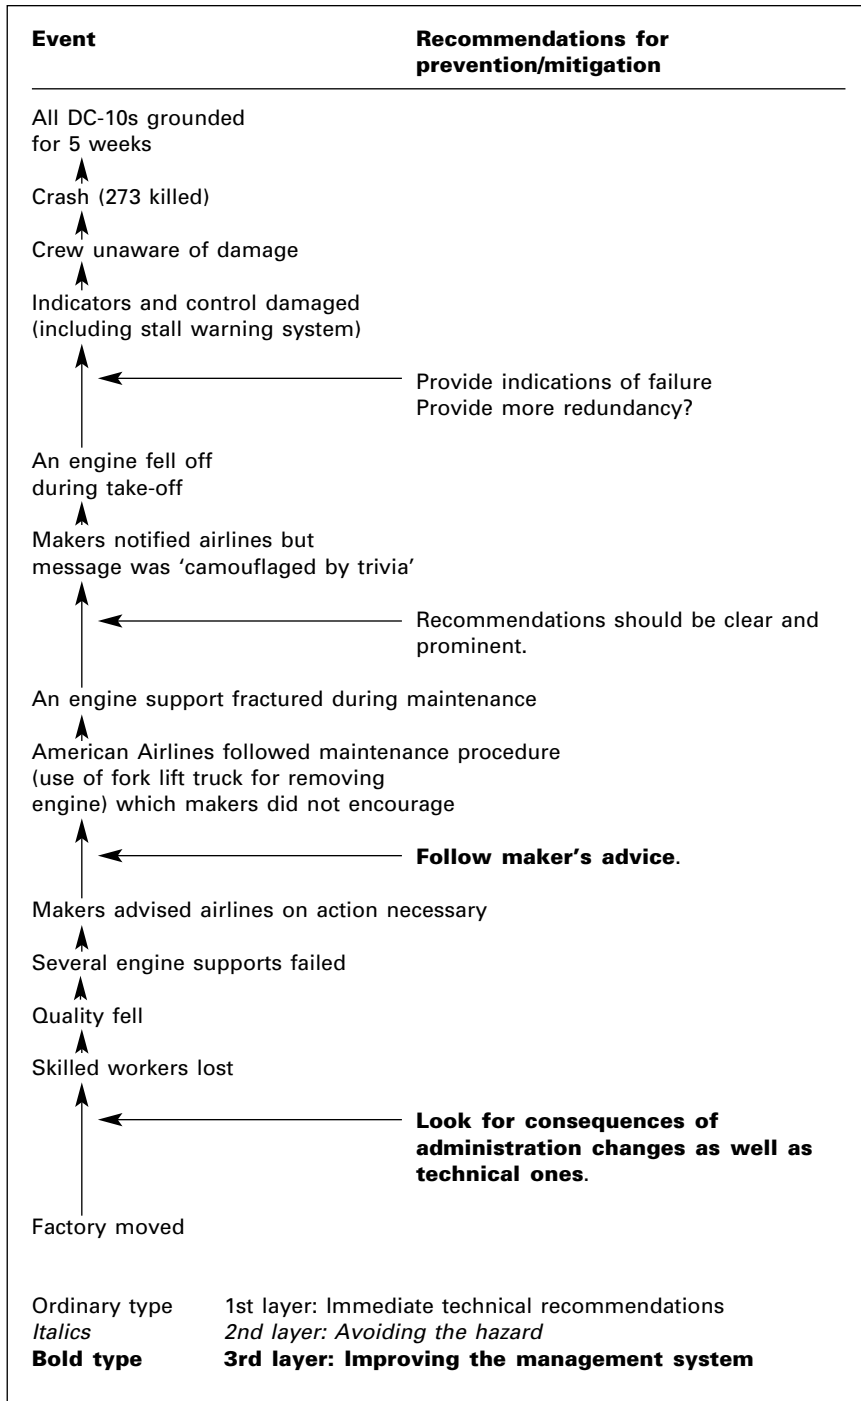
Figure 21.8 The Chicago DC-10 crash

In May 1979 an engine fell off an American Airlines DC-10 while it was taking off from Chicago Airport. All 271 people on board and two people on the ground were killed. The immediate cause was fatigue cracking on an engine pylon flange. Checks showed similar damage on other DC-10s and also discrepancies in various clearances and failed or missing fasteners.

The story started in 1974 when pylon assembly was moved from one factory to another, skilled men were lost and quality fell. In 1975 the manufacturers, McDonnell-Douglas, asked the airlines to carry out certain maintenance work on the pylons. Instead of dismantling the engine *in situ*, as recommended by the manufacturers, American Airlines, amongst others, removed the pylon assembly as a whole using a fork lift truck. This was cheaper and quicker though the manufacturers said they would not encourage the procedure. They did not specifically forbid it.

In 1978 a pylon flange failed on a Continental Airlines DC-10 during maintenance. A report on this incident was circulated to other airlines but it was camouflaged by the trivia of other incidents and did not make it clear that the failure was related to the method used for removing the pylon.

When an engine fell off in flight the power supply to various instruments and warning systems was lost, the pilots did not know that a stall was imminent and were unable to prevent it. Perhaps more redundancy in the power and warning systems was needed.
